## Reuse and transformation Findings report

*KA13 - Kristian Augusts gate 13*

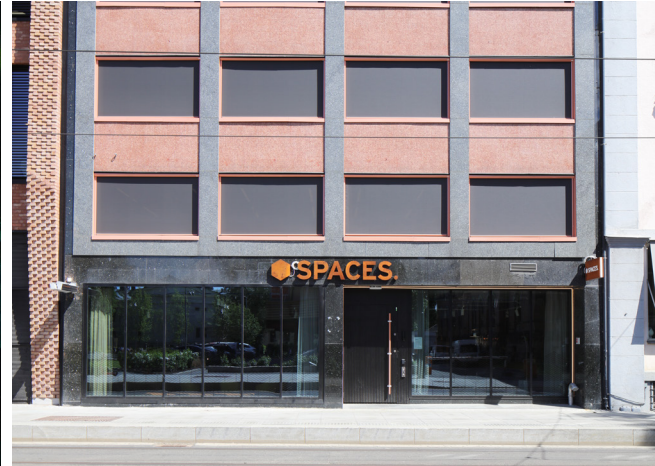
*The fitted glass panel facing out  
onto Kristian Augusts Gate.  
Photo Kyrre Sundal*

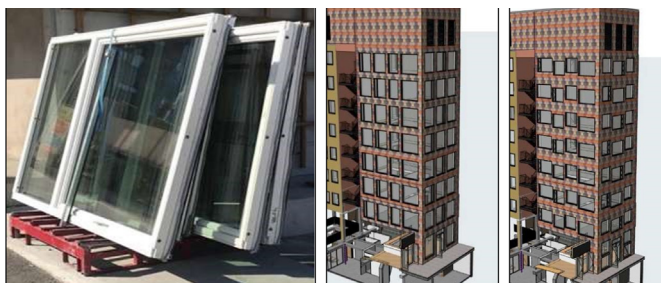
The windows were removed from a housing project in Kværnerbyen. Photo: Resirgel  
Extension façade, designed with 1) new windows, 2) used windows. Illustrations: Mad Arkitekter

Haandverkerne were responsible for transport from Resirgel's warehouse and for the installation of the windows. The openable panes were allowed to block the opening function in order to ensure against opening/falling. 28 used windows were installed on floors 4 to 7 of the extension. There are 16 measuring 1,488 x 1,588 mm and 12 measuring 2,188 x 1,588 mm. 2 used windows (in other forms) were installed on the ground floor facing the back courtyard and in the meeting room on the first floor. Resirgel were able to provide the relevant FDV documentation and CE labelling for all of the windows. The windows can be dismantled and reused.

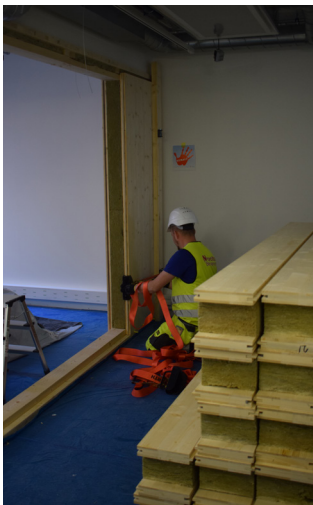
*Assembly of the Tewo walls.  
Photo: Anne S Nordby and Catriona Shine*

In total, approx. 160 m<sup>2</sup> of Tewo walls have been installed in KA13. The product has been installed for use as office partitions and as walls between meeting rooms and offices.

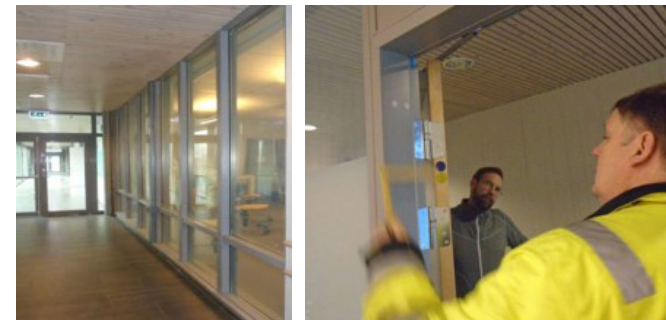
From the Refstad school inspection. Photo: Anne S Nordby

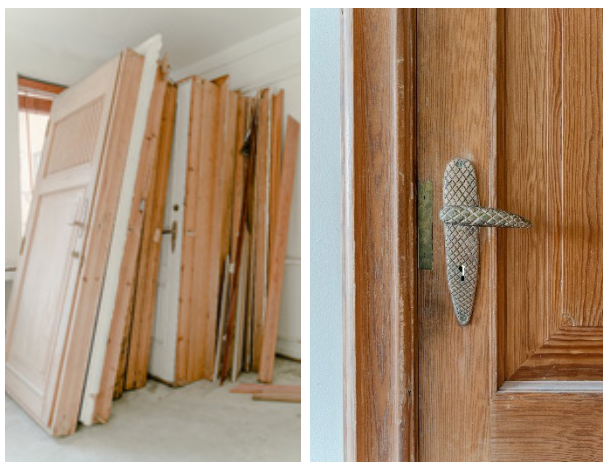
Existing doors, Photo: Kyrre Sundal

17 of the existing doors in KA13 were reused. 7+4 (all of the utility room doors + 4 doors from the 5th floor) were kept in their original position. The rest of the doors were moved to new walls. The doors on the 5th floor are only green soap washed. The rest of the reused doors have been cleaned and surface treated.

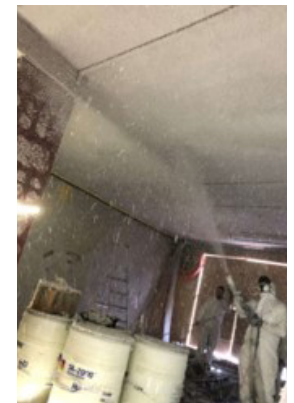
Raw material of ground recycled paper. Photo: Kristine Aassved Storeide

For the ground floor and basement ceilings, a recycled product was chosen: ThermoCon cellulose spray. The product consists of ground-up recycled paper combined with a water-based glue and is sprayed onto the ceiling. Specifications for installation in KA13 are ThermoCon SB. The spray is of a light grey colour and it is applied as a 40mm thick layer. In total, approx. 600 m<sup>2</sup> of cellulose spray was applied.

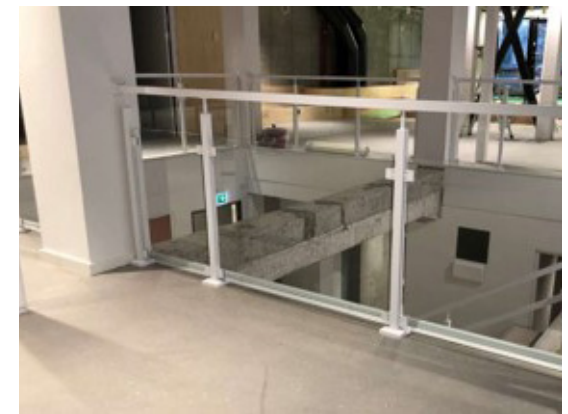
Glass railings, St. Olavs plass 5. Photo: Norconsult  
Glass panel with new frames in KA13. Photo: Rune Andersen

11 used glass panels from the railings in St. Olavs plass 5 (equivalent to approx. 24.5 m<sup>2</sup> of glass) were used in the new railings

Haandverkerne dismantled the panels, and CreoNordic carried out the installation. Used glass has been installed in the new steel profiles. The adjusted panels are made of new glass.

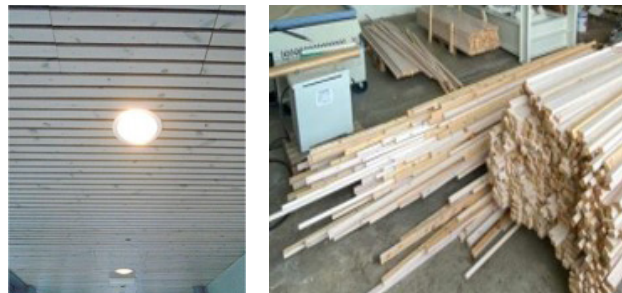
Wooden slats dismantled from the ceiling in the corridors of Refstad school. Photo: Anne S Nordby  
Storage and production at LUN. Photo: Lars Ulrich Nielson

The wooden slats have been a great resource for this project and have provided the opportunity to use aesthetically pleasing sound absorption that has few consequences for the project. In total, there are approx. 760 lm of wooden slats repurposed for this project, found in the:

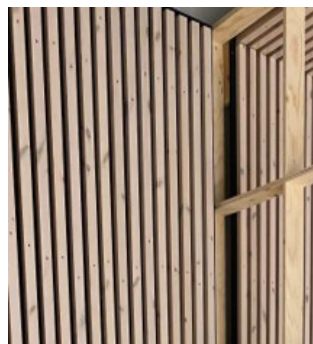
Installation in KA13. Existing screw holes that were kept. Photo: Kristine Aassved

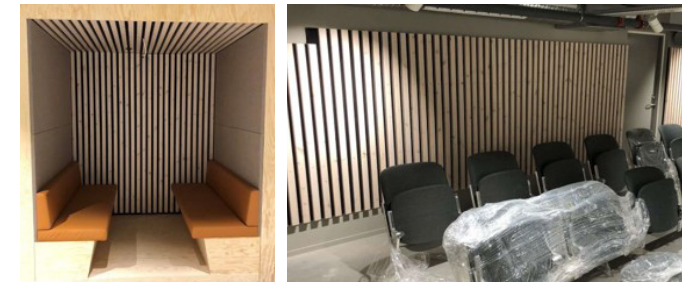
Completed booths and cladding made of used slats on the back wall of the cinema room. Photo: Rune Andersen

- Booths: c. 400 lm
- Cinema room: c. 360 lm

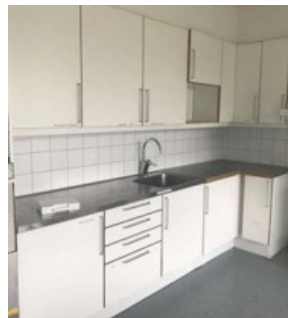
*The kitchen units/fittings from Lambertseter sykehjem.  
Photo: Rehub/Rambøll*

The dismantling of the kitchen cabinets and the faucets was carried out by Haandverkerne and the plumbers alongside work conducted by the emergency response team. 2 base cabinets were missing, as some of the cabinets sustained damage. We did, however, find an opportunity to complement the cabinets in St. Olavs Plass 5. The fittings from Lambertseter sykehjem and St. Olavs Plass were transported first to a warehouse in Vollebekk, then to the construction site. IARK and LUN carried out an inspection in order to assess the standard of the fittings. The fittings were considered good enough for reuse.

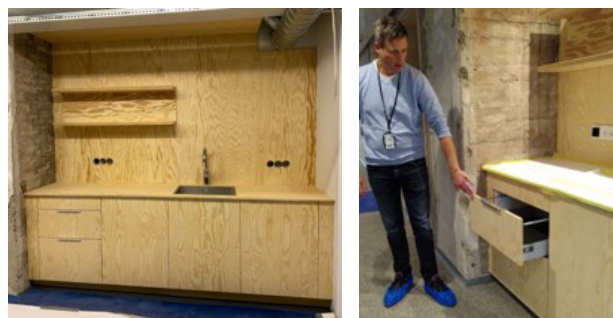
*Fully installed cabinets with new fronts made of 15mm plywood.  
Photo: Lars Ulrich Nielson/LUN and Anne S Nordby*

LUN manufactured new fronts, linings and bases in 15mm plywood to adhere to the sketches provided by IARK. The original plan had been to reuse plywood for the temporary barriers set up on the construction site, but this was too thin and unstable for use in this way. LUN also produced the worktops, backboards and wall shelves, as well as the ceiling components above the kitchen. The plywood used for the fronts was matte-varnished and will withstand the usage of the premises well.

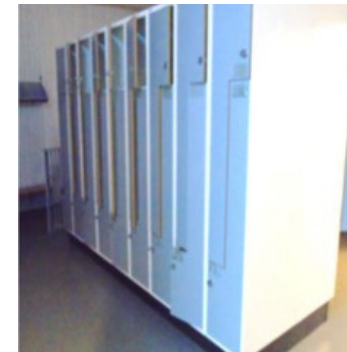
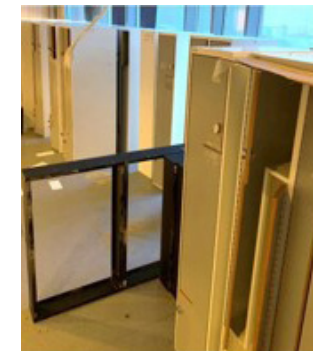
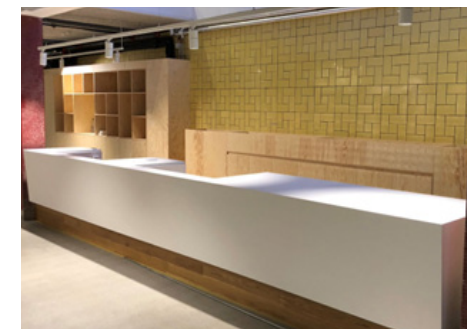
1-2: The lockers in the changing room at Refstad school and in storage.  
Photo: Anne S Nordby and Randi Lunke  
3: Corian reception desk.  
Photo: Rune Andersen

We were able to select lockers and other units from Refstad school after the other schools in Oslo marked the equipment they wanted to take. There were many changing room lockers left over, and we chose those that were in best condition. The lockers were stored at Vollebekk until they had to be moved to the Posthuset building in Oslo due to the rental contract expiring at the warehouse in Vollebekk.

The reception desk followed a clear design profile for Spaces, which is not usually deviated from. The desk is made of Corian plates. Corian is a material that can be easily reused/upcycled by welding smaller pieces together into larger components and new designs. We chose to deviate slightly from the design profile in terms of which colour of white to use in order to reuse the Corian plates from other used reception desks.

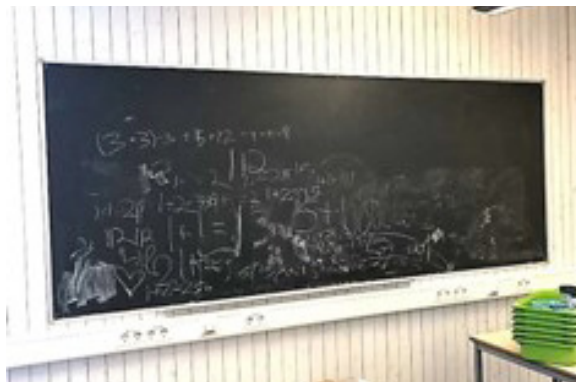
School boards from Refstad school.  
Photo: Kristine Aassved Storeide

The boards provide an overview of all of the building's tenants and the text can be easily replaced. The boards add an aesthetic twist in that they support the idea of flexibility and reuse. The boards did not incur any costs or have any environmental impact beyond those for dismantling, transport and storage.

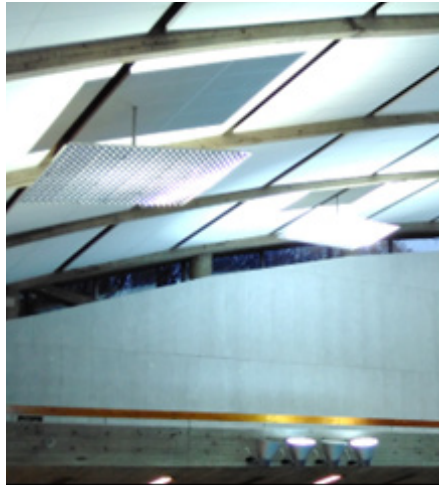
Light shafts with reflectors.  
Photo: Rune Andersen

The brackets were shortened so that the reflectors could be attached closer to the wall and be tilted up and down for the desired effect. No repairs were required for the reflectors. The reflectors were temporarily stored in the Posthuset building after being dismantled from Tøyenbadet.

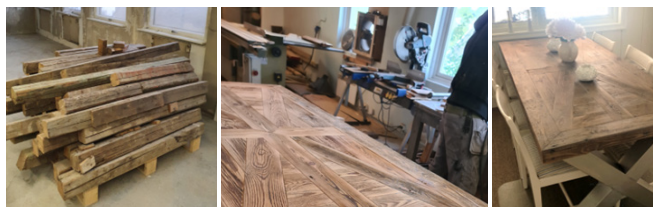
*Surplus after demolition: A stack of structural timber transformed into beautiful tables. Photo: Driftwood*

A stack of beams of approx. 4x4-inch timber was therefore given to the company Drivved, who make interior products from old wood. Most of the materials were used as table tops for two of the dining tables, where they were laid in a pattern as there were very few beams of good length. The materials were cut, sanded and wire brushed. The tables were then treated with matte hard wax and now find themselves with satisfied customers in a cabin in Larkollen.

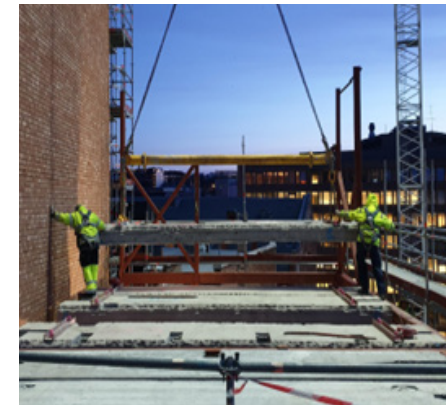
*Lifting the hollow core slabs into place.  
Photo: Mattias Johnsson*

The hoisting was carried out quickly and without any problems. Øst-Riv was responsible for transporting the slabs via the warehouse in Follestad to be prepared for installation (cleaning the grout off and cutting them to the correct length) and then transporting them onwards to the construction site for installation. The hollow core slabs use traditional fixings. They are located on the hat profiles facing the façade and on the H-beams facing the other sides. Joint grout was used between the elements.

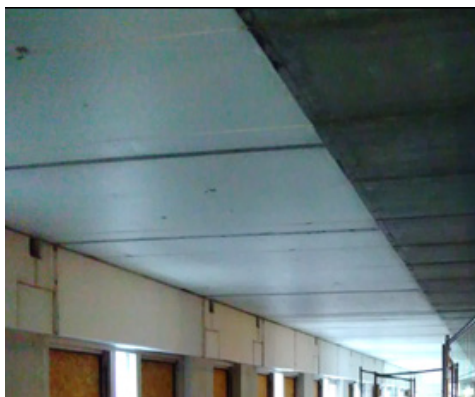
*Hollow core slabs in R4, Regjeringskvartalet.  
Photo: Anne S Nordby*

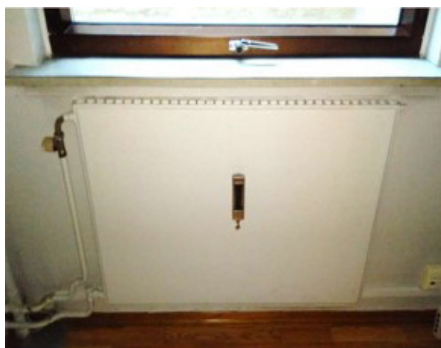
*Original radiators in KA13.  
Photo: Anne S Nordby*

For reusing the old radiators already present in KA13, a capacity assessment was carried out: could they provide enough heat, and would this be the same after an additional coat of paint? One challenge with these radiators was that the heating effect decreased when replacing oil (80 degrees) with district heating (60 degrees). However, this was taken into account in the energy calculations. In the event of lower heating requirements due to the replacement of windows in the existing building, this balances out – at least a little bit.

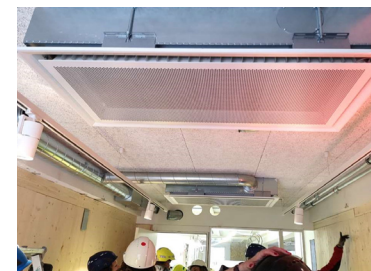
Complete installed beams in the test room of KA13.  
Photo: Christoffer Siopan Engstrø

The chilled beams for comfort cooling were acquired from Dronning Eufemiasgate 8 (DEG8). RIV observed that this was the right type for usage for KA13 and assessed the quality of the chilled beams as good as new. Type: Parasol 1200, Swegon: 1192A-HF.

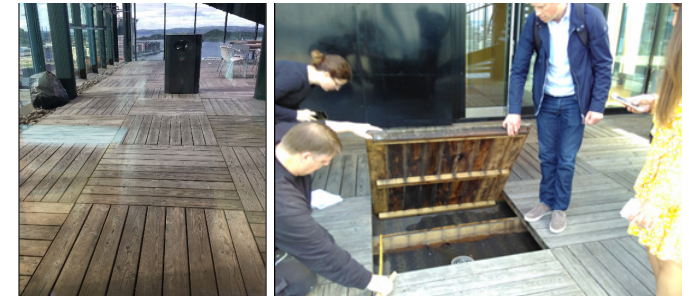
*Wooden decking, DEG8. Photo: Noora Khezri Measuring during the inspection. Photo: Anne S Nordby*

The wooden decking (slats) was found during an inspection of DEG8, then dismantled by Haandverkerne. These were used for the 9th floor roof terrace. The slats were temporarily stored at Haandverkerne's own warehouse in Sem, Asker. The best slats were chosen and the surface then painted in a shade of grey. Ellingard Naturstein carried out the task of adapting the wooden slats and installing them on the pedestals the same way as the roof terrace had been installed on the 2th floor, as this also functions as a blue roof.

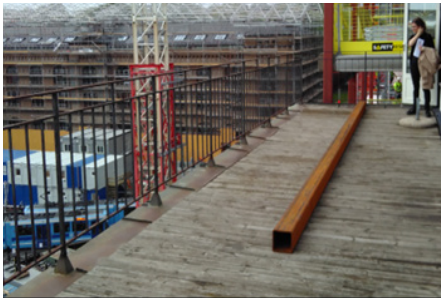
*Railings on the 8th floor, original situation.  
Photo: Anne S Nordby*

The existing railings around the 8th floor roof terrace were preserved and upgraded according to TEK17 requirements by doubling the density of the slats. This was assessed by ARK and carried out by Jomek at the workshop.

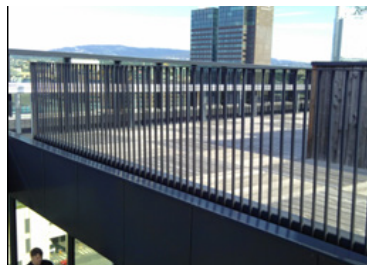
*Railings from the roof terrace in DEG8.  
Photo: Anne S Nordby*

The railings on the 2th and 9th floor roof terraces were reused from DEG8. Jomek and Haandverkerne carried out this work. All of the railings were used as they were and are still reusable for another potential round of reuse. The parapet and flower boxes were prepared with fixing brackets so that the railings could be reassembled at the same angle as originally fitted to the bottom of the railing. It was decided to attach the railings on the 2th floor to the outside of the parapet, which entailed extra challenges regarding the roofing around the attachment point and more complicated adaptation brackets, meaning that RIB had to get involved.

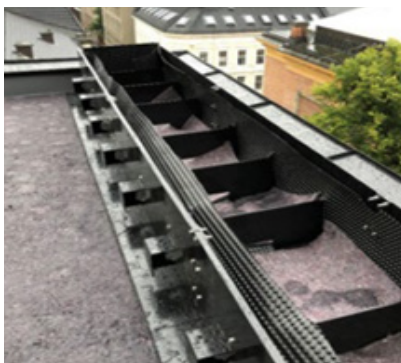
*The planters before filling with soil.  
Photo: Janicke Ramfjord Egeberg*

A search for used steel panels was carried out for the planters, but no suitable panels were found. Steel for the planters was instead supplied by Nordic Steel and assembled by Bergknapp, then delivered to and installed in KA13. The panels for the planters are comprised of 80% recycled steel.

The sketches from LARK were further developed by Bergknapp and Nordic Steel, who prepared the production sketches. The components were then screwed together, so it would be easy to dismantle and possibly reuse the products later.
